DOT/FAA/AM-99/13

GPS User-Interface Design Problems

April 1999

Final Report

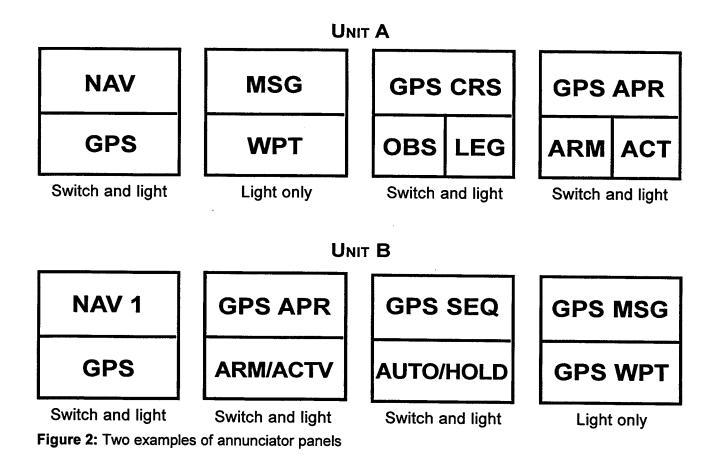
Also, annunciator panels can be made by a third party manufacturer, so that the panel for a particular unit can vary from airplane to airplane. The labeling of GPS modes varied across the units reviewed. Figure 2 shows two of the several different GPS annunciator panels reviewed.

In particular, notice the third box of each annunciator panel in Figure 2, labeled unit A and unit B respectively. TSO-C129a (FAA, 1996), Par (a)(3)(xi)(2), states that, "The equipment shall provide the capability for accomplishment of holding patterns and procedure turns. Activation of this function shall at least: a. Change automatic waypoint sequencing to manual. ... d. Permit the pilot to readily return to automatic waypoint sequencing at any time prior to the designated fix ("TO' waypoint) and continue with the existing flight plan."

For unit A, the annunciator button for manual interruption of autosequencing, for purposes of holding and procedure turns is called GPS SEQ, and includes two modes labeled AUTO and HOLD. Unit B labels their annunciator button GPS CRS, with the two modes labeled OBS and LEG. A third brand, not shown in the figure, does not have an external annunciator button and automatically enters the "hold" function when outbound on an approach and enters an "auto" sequence function when inbound. As will be discussed below, there can be confusion over the labeling and operation of a panel and receiver if a pilot is required to suspend and restart autosequencing.

Designing an "undo" function on all of these receivers would keep the pilot from becoming lost after making an entry error and reduce control inputs during critical phases of flight. Whether standards are imposed by the FAA, or volunteered by manufacturers, some standardization of button labels, annunciator panels, and displays is needed. At a minimum, a core set of GPS functions should be performed in essentially the same way for every unit on the market. John Steuernagle, of the Airplane Owners and Pilots Association Air Safety Foundation, has recommended that standardized procedures be designed for the following set of GPS functions (J. Steurenagle, personal communication, February 3, 1998):
